Context

Working with the Director of Engineering at a 5-star hotel, Nexa was installed at multiple mechanical and guest room locations with temperature and pressure sensors.

The Director of Engineering (DOE) at a 5-star hospitality property asked Nexa to explore the hotel's energy usage for reporting into their corporate team's Environment Social Governance (ESG) program. The scope was around the domestic hot water (DHW) system. Nexa installed temperature and pressure sensors around a portion of the property to understand the performance of 3 DHW branch loops that serve the guest rooms. The layout of the plumbing system was twinned (i.e., modeled) in Nexa to map out the relative locations of sensors. Nexa then processed the data and found opportunities for maintenance that saved a significant amount of energy in just 1 of the branch loops.

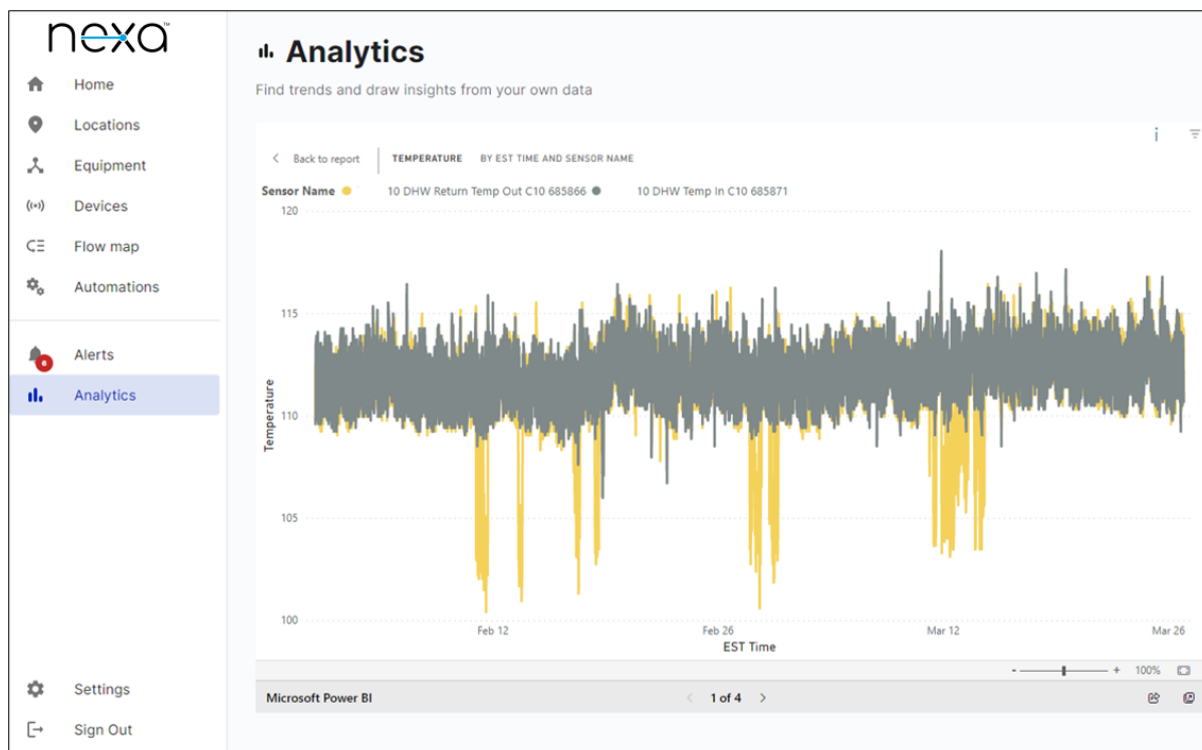
Figure 1 - Comparison of supply and return temperatures into and out of **branch 10**

Intent was to explore where the energy loss occurred. Energy loss requires knowing the water flow rate and change in temperature. The temperature was recorded from the sensors placed on the surfaces of supply and return pipes of different branches. PowerBI within Nexa was used to find and plot the branches over the same time period. Branches 10, 11, and 12 were noteworthy given the large differences in both dTemp across the branch.

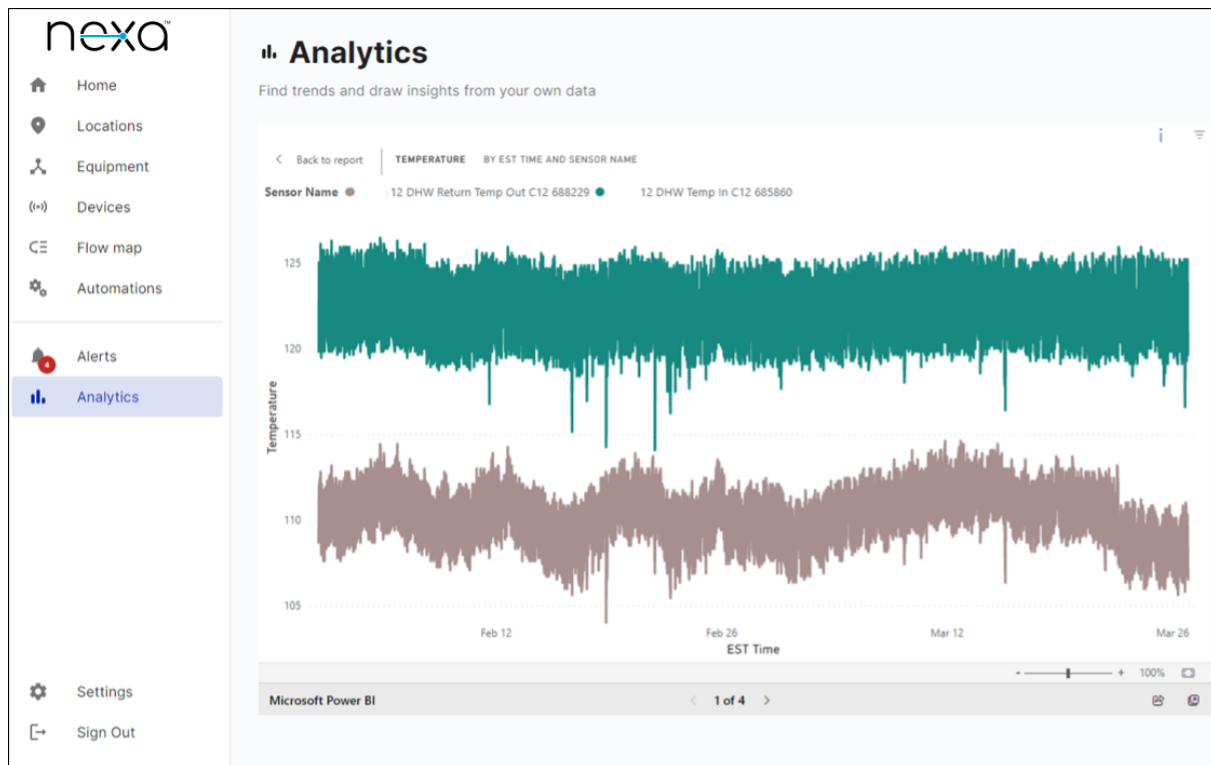
Figure 2 - Comparison of supply and return temperatures into and out of **branch 12**

The Nexa Analytics center showed that the temperature difference across Branch 12 was too wide relative to a baseline, indicating an energy opportunity.

Given the estimated flow rate, it was suspected that the loss in temperature was likely due to cold water flowing into the DHW system points-of-use where mixing occurs, such as shower valves and faucet fittings, rather than a lack of insulation and ambient loss. When the DOE asked when the last time those fittings were serviced or replaced, reply was “they haven’t been in the years that I have been here.” The recommendation was to perform maintenance on each of the guest room fittings along Branch 12: replace check valves, replace seals, and replace fittings as needed.

The DOE and facilities team inspected various shower and faucet fittings and replaced check valves to minimize crossflow of cold water into the DHW system.

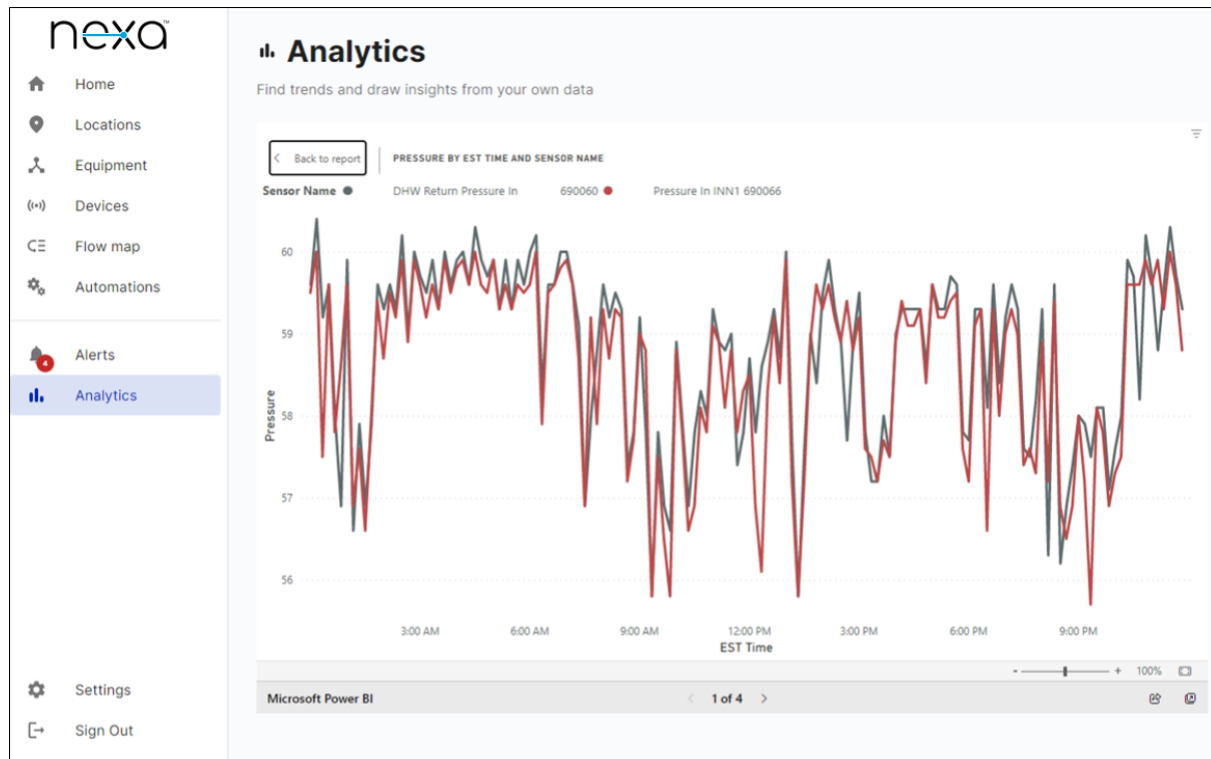
Figure 3 - Pressure readings across the recirculation pump

The flow rate was estimated by measuring the pressure rise across a pump and plotting it against the pump curve. The head across pump is estimated on average to be $\frac{1}{2}$ psi or 1.2ft of head. Given the pump curve, it is estimated that on average the flow rate is approximately 30 GPM.
