**Partnering with a luxury hotel property, Nexa installed temperature and pressure sensors in multiple mechanical rooms and guest buildings at the hotel.**

**Nexa detected a sudden drop in guestroom water pressure and temperature, triggering an alert to the property engineers which showed them which guestroom buildings and rooms would be impacted**

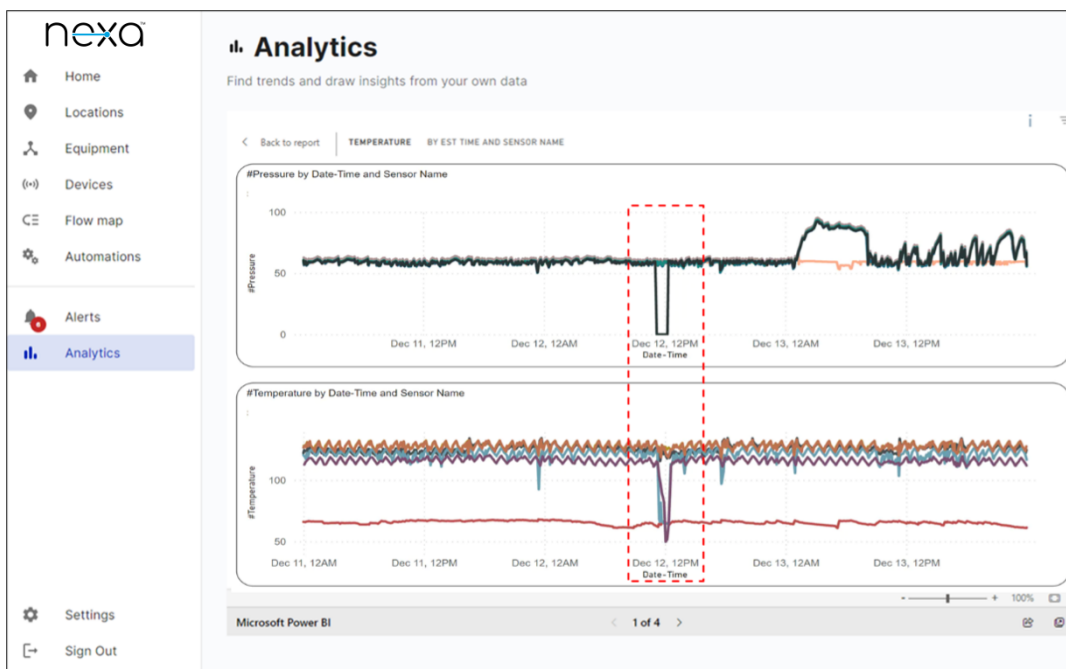
On December 12<sup>th</sup>, Nexa detected a sudden drop in both guestroom water temperature and pressure.

Figure 1 – Sudden drop in both guestroom water pressure and temperature detected on December 12<sup>th</sup>

Based on the magnitude of the drop, this would have had a major impact on guest comfort, and the Nexa system immediately sent an alert to the property engineering team notifying them of this issue.

The Nexa team then called the property engineering team to check-in on this issue and discuss what might be the root cause. The property engineer mentioned that there had been construction activity taking place on the property near the mechanical rooms. When the property engineers went to check on the construction, they discovered that the construction crew had closed one of the DHW pipes out of precaution but had not yet informed the property engineering team.

**The property engineers paused construction and re-opened the DHW pipe so that water pressure and temperature returned to normal levels, and re-scheduled the construction activities from daytime to nighttime, when it would have the least disruptive impact on guests**
