Luxury Hotel Guest Impact Case Study

NEXA ALERTS PROPERTY OF GUEST ROOM WATER ISSUES, AND AVERTS UP TO \$4K OF COST

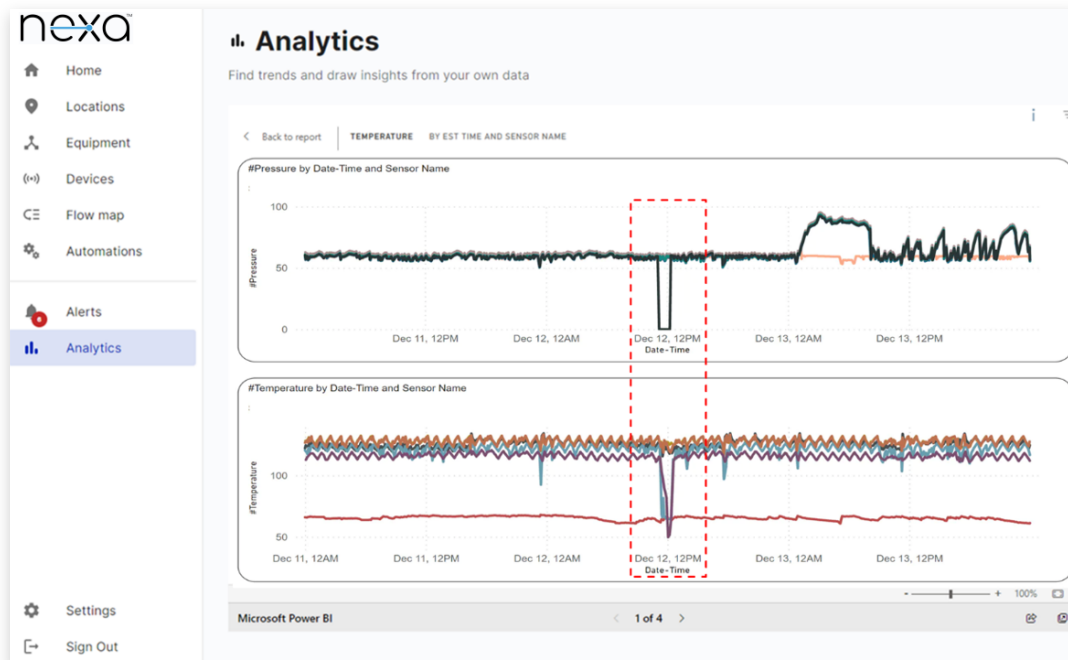
On December 12th, Nexa detected a sudden drop in both guestroom water temperature and pressure.

FIGURE 1 – SUDDEN DROP IN BOTH GUESTROOM WATER PRESSURE AND TEMPERATURE DETECTED ON DECEMBER 12TH

Based on the magnitude of the drop, this would have had a major impact on guest comfort, and the Nexa system immediately sent an alert to the property engineering team notifying them of this issue.

The Nexa team then called the property engineering team to check-in on this issue and discuss what might be the root cause. The property engineer mentioned that there had been construction activity taking place on the property near the mechanical rooms. When the property engineers went to check on the construction, they discovered that the construction crew had closed one of the DHW pipes out of precaution but had not yet informed the property engineering team.

The property engineers paused construction and re-opened the DHW pipe so that water pressure and temperature returned to normal levels, and re-scheduled the construction activities from daytime to nighttime, when it would have the least disruptive impact on guests.
