# Luxury Hotel Energy Case Study

NEXA IDENTIFIES SYSTEM INEFFICIENCY AND SAVES PROPERTY \$40K PER YEAR ON COSTS

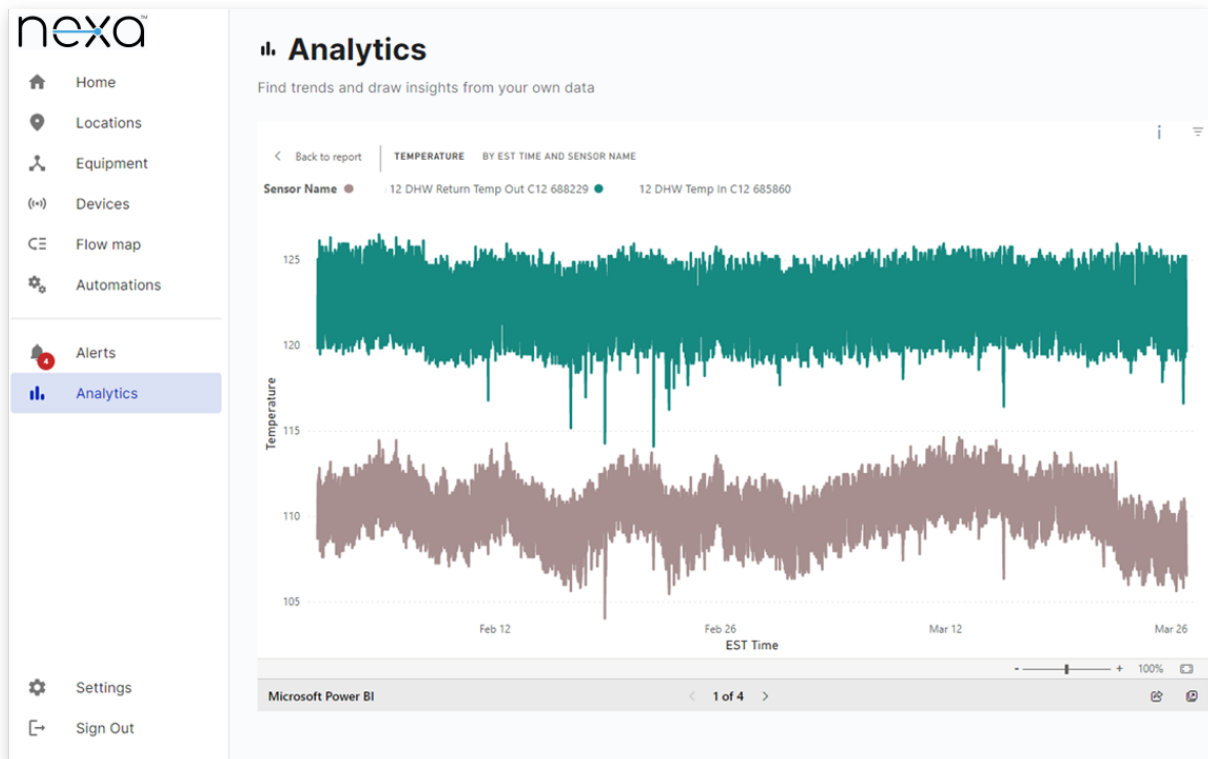
FIGURE 2 - COMPARISON OF SUPPLY AND RETURN TEMPERATURES INTO AND OUT OF BRANCH 12

The Nexa Analytics center showed that the temperature difference across Branch 12 was too wide relative to a baseline, indicating an energy opportunity.

Given the estimated flow rate, it was suspected that the loss in temperature was likely due to cold water flowing into the DHW system points-of-use where mixing occurs, such as shower valves and faucet fittings, rather than a lack of insulation and ambient loss. When the DOE asked when the last time those fittings were serviced or replaced, reply was “they haven’t been in the years that I have been here.” The recommendation was to perform maintenance on each of the guest room fittings along Branch 12: replace check valves, replace seals, and replace fittings as needed.

The DOE and facilities team inspected various shower and faucet fittings and replaced check valves to minimize crossflow of cold water into the DHW system.

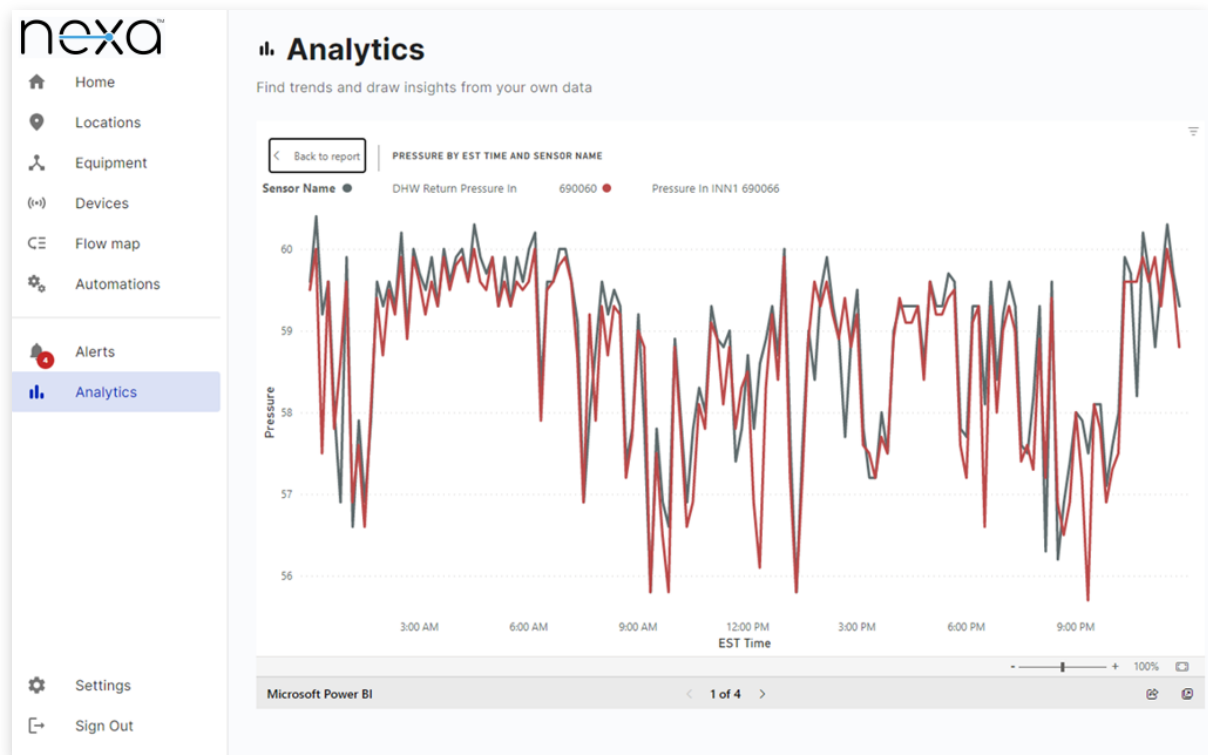
FIGURE 3 - PRESSURE READINGS ACROSS THE RECIRCULATION PUMP

The flow rate was estimated by measuring the pressure rise across a pump and plotting it against the pump curve. The head across pump is estimated on average to be  $\frac{1}{2}$  psi or 1.2ft of head. Given the pump curve, it is estimated that on average the flow rate is approximately 30 GPM.
